**US Army Corps
of Engineers®**

Engineering Documentation Report

Green River Lock and Dam No. 3
Contract No. W912QR-08-D-0005
Task Order No. 0008
Rochester, Kentucky

May 18, 2011

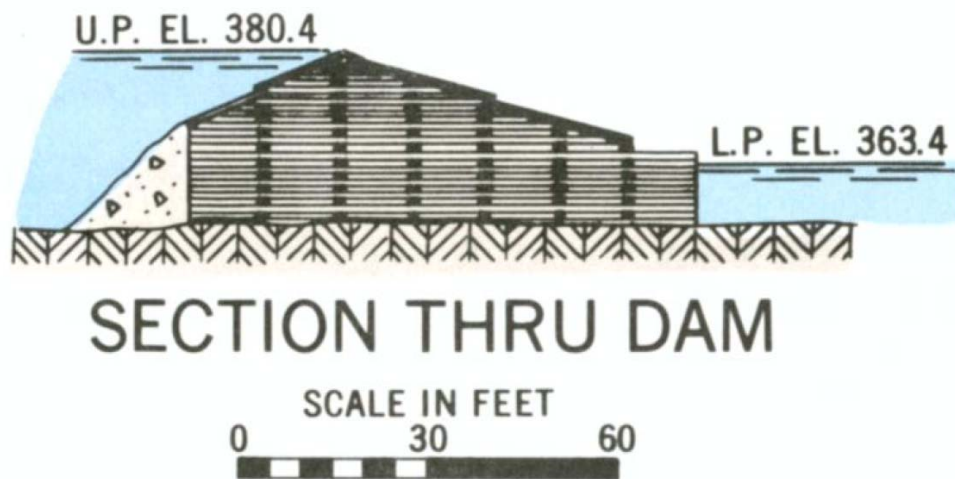
Figure 3. Schematic Cross Section of Dam No. 3 (USACE 1995)

The only cross section located for the dam is a schematic (Figure 3) from the USACE Project Data Sheet (1995). The basis for this schematic is unknown, and the elevation datum is unclear. The elevations shown in Figure 3 are inconsistent with the adjusted elevations shown in Table 2. The schematic indicates a timber crib structure bearing on rock, with a wedge of undefined fill material (possibly an earthen berm or cofferdam) along the upstream vertical face of the structure. If the scale is correct, the dam has a base width of approximately 81 feet (25 feet upstream of the crest, 56 feet downstream), a maximum height of approximately 27 feet, and a stepped downstream planking face that spills water onto a horizontal wooden apron that is slightly above the minimum lower pool elevation controlled by Green River Dam No. 2. The schematic does not reflect the derrick stone that was placed over the dam in 1966, nor does it show the accumulation of sediment upstream of the crest (which is apparent in recent photos taken when the river is extremely low).

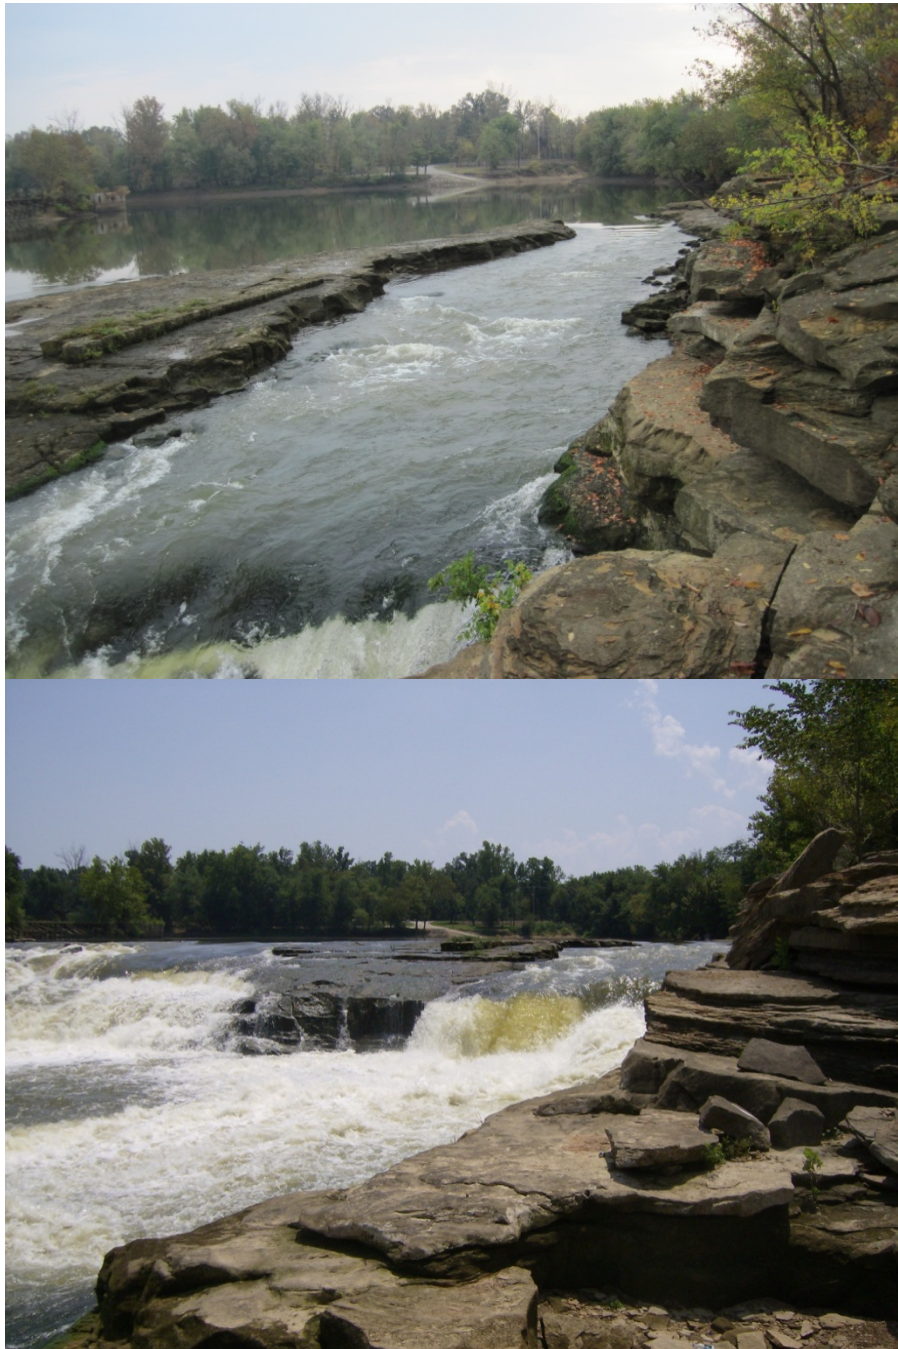
**Figure 13. Mill Race at Green River Lock
and Dam No. 3**

Between the above mentioned rock shelf and the rock bluff at the west (left) abutment is an excavated rock channel called the “mill race” (Figure 13). Visual observations during low water confirm that the mill race has a lower controlling/crest elevation than most of the dam and the rock shelf. Although not documented, it is presumed that this channel was excavated around 1848, when Brewer’s Mill was constructed at the west abutment. Photos taken in 1939 would indicate that for some period of time, a wooden control section was constructed across the dam, rock shelf and the mill race, presumably to provide a consistent crest elevation over the width of the river. Note that the geometry of the mill race channel could not be surveyed during this study due to swift currents and related safety concerns. Future phases of design should include efforts to better define this area, in order to reduce uncertainty during construction.

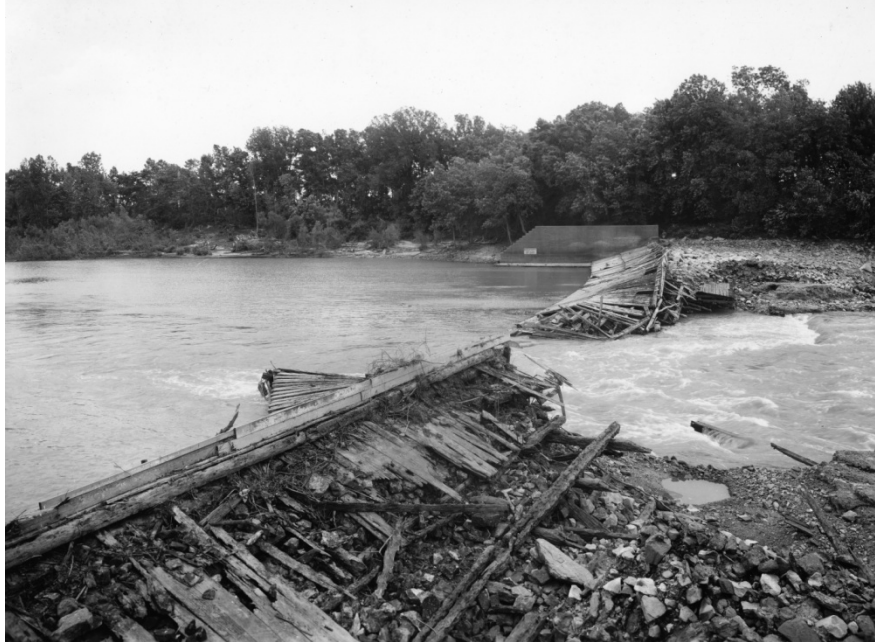
If no action were taken, an indicator of possible future events at Lock and Dam No. 3 is the May 24, 1965 washout (failure) of Lock and Dam No. 4. Although historical documentation is limited, Dam No. 4 suffered a breach of the center portion of the timber crib dam (Figure 14). As shown in the photos, this structure did not have any derrick stone armoring. This event, as well as subsequent “possible failure due to loss of stone from the timber cribs” (Oliver 1987) led to the placement of derrick stone armoring in 1966. The failure of Dam No. 4 may have resulted from deterioration or loss of timber planking/framing, followed by progressive loss of rock fill and further collapse of timber framing. The presence of derrick stone at Dam No. 3 could help to slow or arrest this type of progressive failure by falling into the breach and providing some degree of stabilization. The result might be a narrower breach and/or a slower progressive failure. However, it is also possible that after the initial breach forms, the derrick stone does not shift significantly, and an area of rock fill remains exposed for an extended period, allowing for a larger breach similar to Dam No. 4.

LOUISVILLE DISTRICT, CORPS OF ENGINEERS, U. S. ARMY. Date: 1 June 1965 File No. 37463
 Green River, Locks and Dam #4. General view of dam from Lock River Wall showing condition of upstream decking and crib.

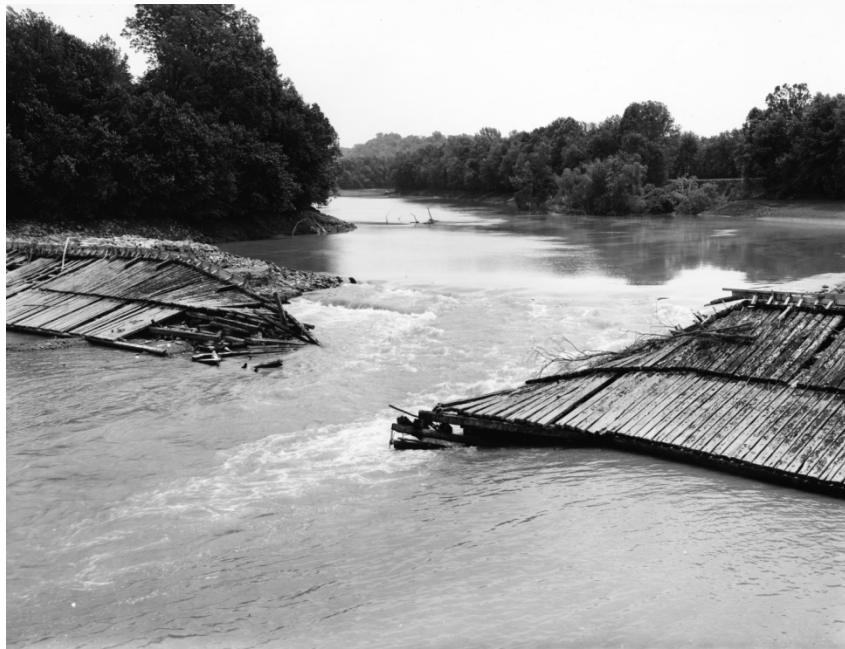
LOUISVILLE DISTRICT, CORPS OF ENGINEERS, U. S. ARMY. Date: 1 June 1965 File No. 37472
 Green River, Locks and Dam #4. General view upstream showing breach in dam.
